Modelling of the HMAS Westralia Fire

DSTO-TR-0698

# MODELLING OF THE HMAS WESTRALIA FIRE

The HMAS Westralia fire incident of 5 May 1998, involved the combustion of a quantity of diesel fuel in the engine compartment. Four sailors were killed and the ship disabled.

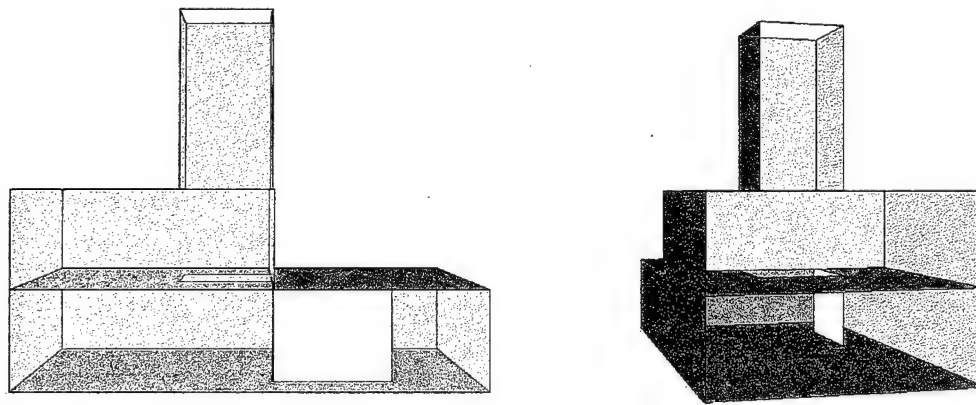
*Figure 5 Isometric projections of the model compartment. The yellow bulkhead is the bulkhead adjacent to the fire source. The fire source is indicated by an orange dot.*

The location of the fuel source is indicated as an orange dot in Figure 5. A flow of fuel was directed at an angle of 45 degrees to the horizontal towards the starboard wall. The flow rate of fuel was set to 0.5 L/s. The flow of fuel was cut off after 60 seconds giving a total fuel load of 30 L of diesel equivalent.

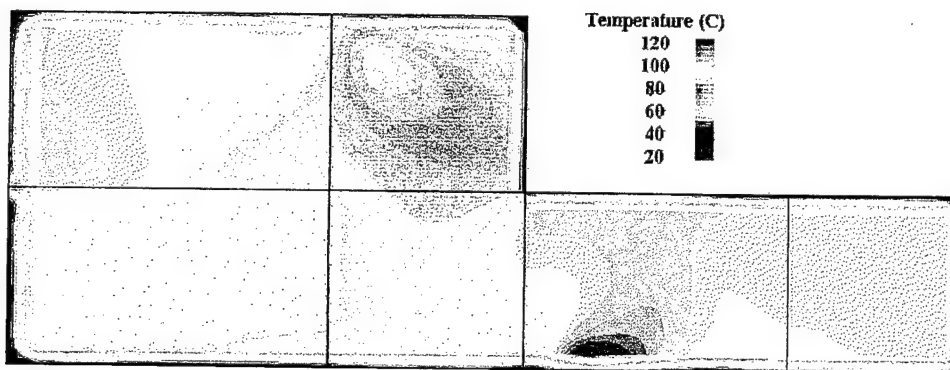
In the modelled scenario the fuel source is removed 1 minute into the event and the compartment is allowed to cool. A longitudinal compartment section through the origin of the fire is shown, in Figure 17, four minutes into the event. The temperature in the region of the cargo pumps and the diesel generators on the lower platform has reduced significantly over the temperature after one minute and become evenly heated at about 100°C. Cool air can be seen to be flowing down from the stack just aft of the MCR.

Figure 17. The predicted temperature distribution is shown for a section through the origin of the fire three minutes after the fuel supply is cut to the fire.

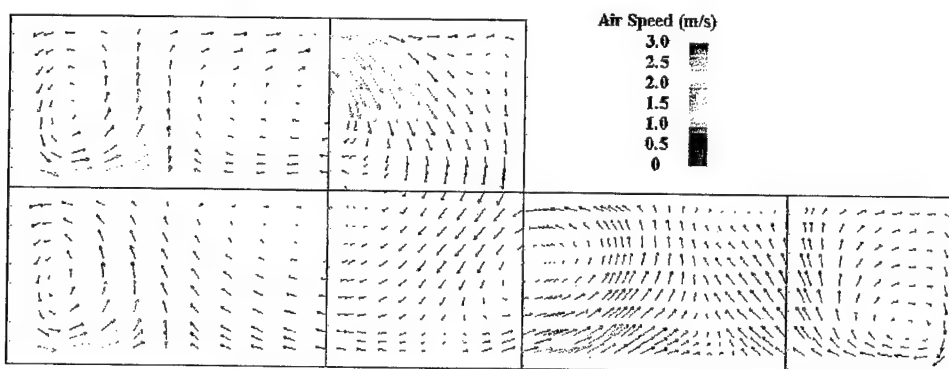
The predicted flow pattern depicted in Figure 18, shows a series of slowly swirling eddies supported by convective gas flows caused by heat losses to the compartment walls and to the atmosphere through the opening at the top of the stack.

Figure 18. The residual airflow for the simulated incident is shown for a section through the origin of the fire. The downward flow of cool air from the open stack and the associated circulations are clearly visible.

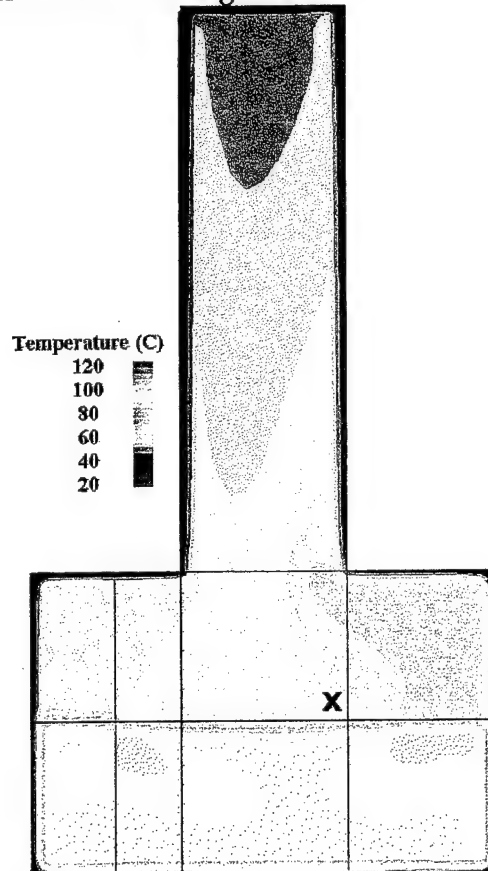
The stack provides the main flow of heat out of the compartment. The large surface area of the stack allows conduction to cool the air and the opening at the top of the stack allows warm air to leave compartment, which is replaced by a down flow of cool air into the compartment. Figure 19 shows the predicted temperature distribution for a cut just aft of the MCR four minutes into the event. Temperatures in the compartment at the level of the MCR and below remain at levels considered too high for firefighting above 80°C [9]. Cool air from the stack has penetrated to the region of the top of the port escape ladder, marked with an X in Figure 19.

Figure 19. The predicted temperature distribution is depicted for a section just aft of the MCR, facing aft, four minutes into the modelled incident. The blue area corresponds to a downdraft of cooler air flowing back down the stack. The x marks the location of the top of the port escape ladder.

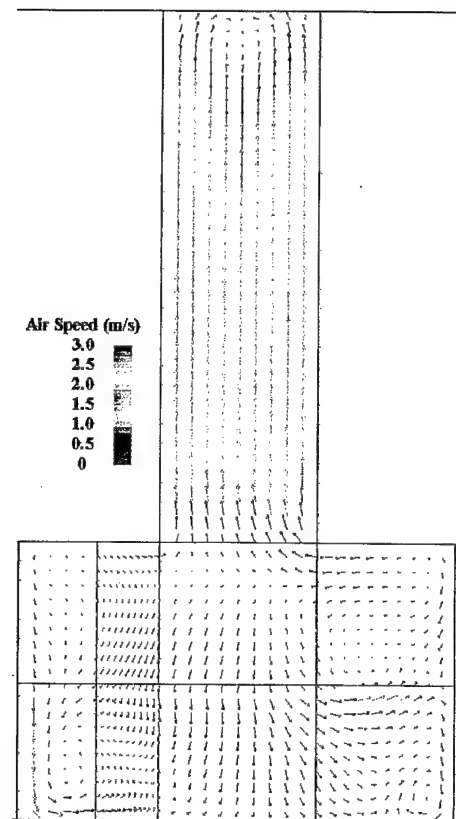
Four minutes into the event the airflow in the lower sections of the compartment is no longer driven by the heat of the spray fire but is driven by convective eddies created by the cool hull locally cooling the air. The upper section of the compartment is still subjected to convective cooling as warm air escapes up the stack. Figure 20 shows the predicted airflow at 4 minutes for a section just aft of the MCR looking aft. The flow up the stack is linear in this section and upward. However sections further aft reveal a complex flow of warm air rising and cool down drafts.

Figure 20. The air speed is shown to the same section as in previous figure. The velocities are generally low less than 1.0 m/s except in the region of the stack. Convective eddies driven by the cool hull provide the main flow in the compartment below the level of the MCR.

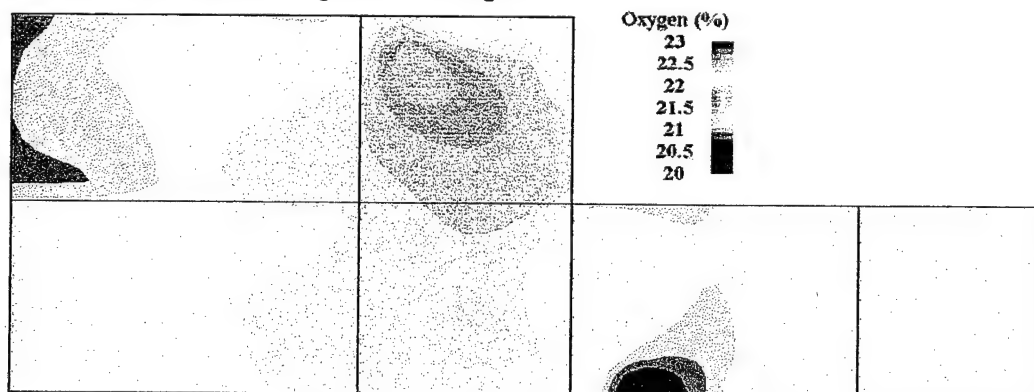
The oxygen level in the compartment four minutes into the modelled event shows the levels to be only 10% less than normal. The levels being most depressed near the fire origin and at the fridge flat. Figure 21 shows the predicted oxygen levels at four minutes for a section through the fire origin.

Figure 21. The predicted oxygen levels for a section through the fire origin is shown.

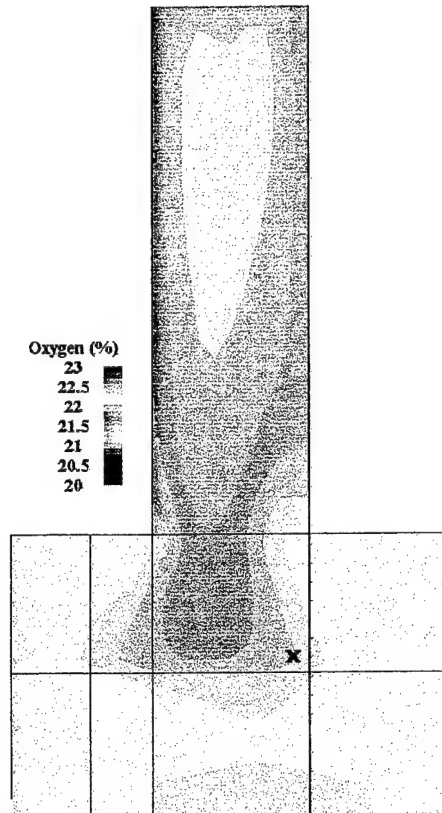
Figure 22 shows the oxygen content in the compartment for a section across the compartment just aft of the MCR looking aft. Clean air is seen to be flowing back into the compartment through the opening at the top. The overall oxygen level is near normal level throughout the compartment.

Figure 22. The predicted oxygen levels four minutes into the event for a section through the compartment just aft of the MCR, looking aft. The opening at the top of the stack has allowed the inflow of fresh air.

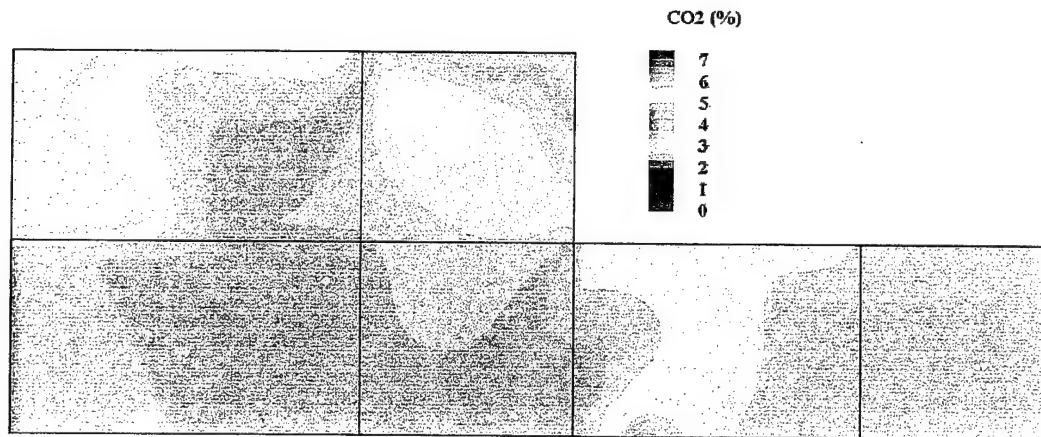
The level of  $\text{CO}_2$  throughout the compartment is still high indicating mixing of the combustion products with the inflowing air. The levels are highest near the origin of the fire and at the fridge flat, see Figure 23. The effect of the down flow of fresh air from the stack can be seen in the area aft of the MCR as a reduced concentration of  $\text{CO}_2$ .

Figure 23. The levels of CO<sub>2</sub> are shown for a forward-aft section through the fire origin. The effects of residual fuel can still be seen near the fire origin. The rest of the compartment shows an even level of CO<sub>2</sub> at about 4%. The effect of the inflow of clean air down the stack is evident.
